WATER DAMAGE ASSESSMENT

**Massachusetts Department of Mental Health
North County Services Site
515 Main Street
Fitchburg, Massachusetts 01420**

Prepared by:
Massachusetts Department of Public Health
Bureau of Environmental Health
Indoor Air Quality Program
June 2017

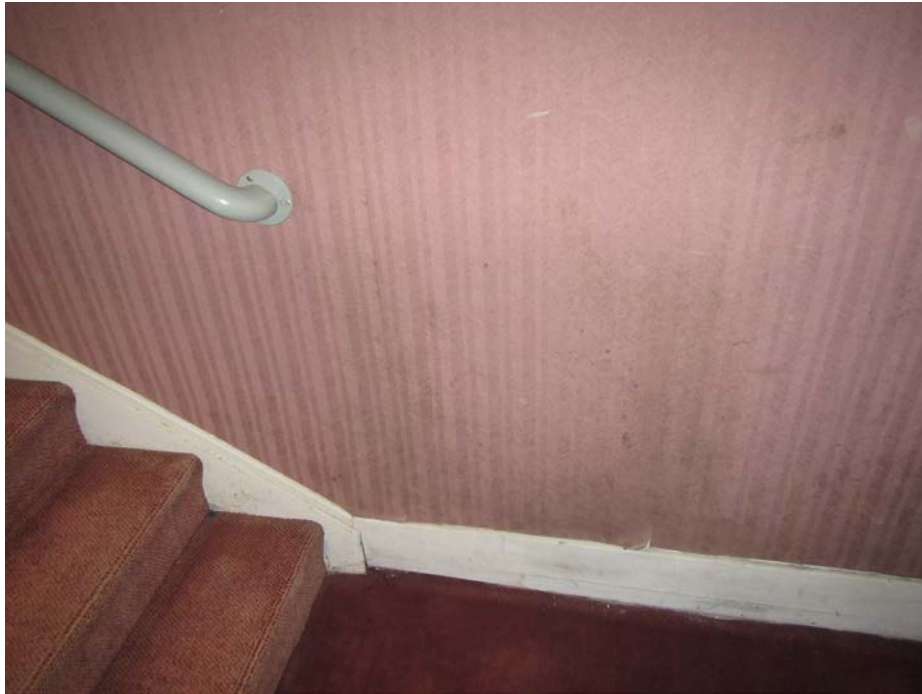
Picture 1

Upon entering the front door of the building, a musty odor was detected. This odor was also detected in the first and second floor hallways as well as the connecting hallway. The source of the odor appears to be the stairwell leading to the basement and its landing. IAQ staff examined the basement level to identify a source of this musty odor. IAQ staff found the wallpaper, wooden baseboard (Picture 1) and the carpeting on the basement landing and stairs to be water-damaged and/or moistened.

- As reported by the building's owner, the adjacent building experienced a flood due to sprinkler activation. It is possible that water from this flood penetrated through the adjacent walls to moisten these materials.
- A second possible source is condensation. As reported by the building owner, the basement stairs are stone. Given when the building was constructed, in the late 1800's, it is unlikely that the basement floor has either a vapor barrier or insulation. In this situation, the temperature of the basement floor would be the same as the ground it is in contact with. BEH staff measured the surface temperature of the basement landing and the stairs which ranged from 43°F to 48°F. Because the dew point of the air at the basement floor landing was calculated to be 43°F, condensation would be occurring on the stairs which would moisten the carpeting.

The US Environmental Protection Agency (US EPA) and the American Conference of Governmental Industrial Hygienists (ACGIH) recommends that porous materials (e.g., wallboard, carpeting, ceiling tiles) be dried with fans and heating within 24 to 48 hours of becoming wet (US EPA, 2008; ACGIH, 1989). If porous materials are not dried within this time frame, mold growth may occur. Once mold has colonized porous materials, they are difficult to clean and should be removed. As shown above, it is very likely that carpeting on the stairs, as well as wood coving, wallpaper and other porous materials in this area are mold-colonized, resulting in the odor detected.

Carpet, wallpaper and wood baseboard; note wallpaper discoloration/peeling

1. Remove carpeting from the basement stairs and landing a manner consistent with US EPA “Mold Remediation in Schools and Commercial Buildings” (US EPA, 2008). This work should be performed when the building is unoccupied.

2. Remove the baseboard and wallpaper directly above the basement stair landing. Wallpaper should be removed to at least a height of three feet above the landing floor. Examine wallpaper higher than the three-foot level above the stairwell landing for water damage/mold and odors and remove as needed.

3. It is recommended that no carpeting be reinstalled in the basement stairs and the landing due to the likelihood of chronic moistening of these materials. In addition consider avoiding coving and wallpaper at all in this area to allow for more rapid drying.
